ASIAN CARDIOVASCULAR & THORACIC ANNALS

A Case of 24 Years Longevity of an Ionescu-Shiley Bioprosthesis in the Mitral Position

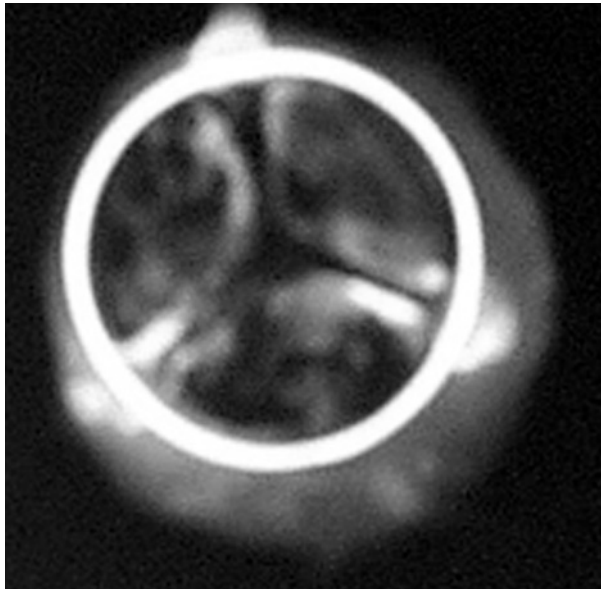
Figure 1. X-Ray examination of the removed valve revealed remarkable calcification observed almost uniformly in all leaflets.

was implanted, and tricuspid annuloplasty was performed using a Cosgrove-Edwards Ring (32 mm diameter) (Edwards Lifesciences, Inc., CA, USA). Postoperative X-Ray examination of the explanted valve revealed almost uniform calcification in all leaflets (Figure 1).
